CONNECTICUT RIVER BASIN  
SHELBURNE FALLS, MASSACHUSETTS

ALBERT DAVENPORT DAM  
MA 00507

PHASE I INSPECTION REPORT  
NATIONAL DAM INSPECTION PROGRAM

MARCH 1981

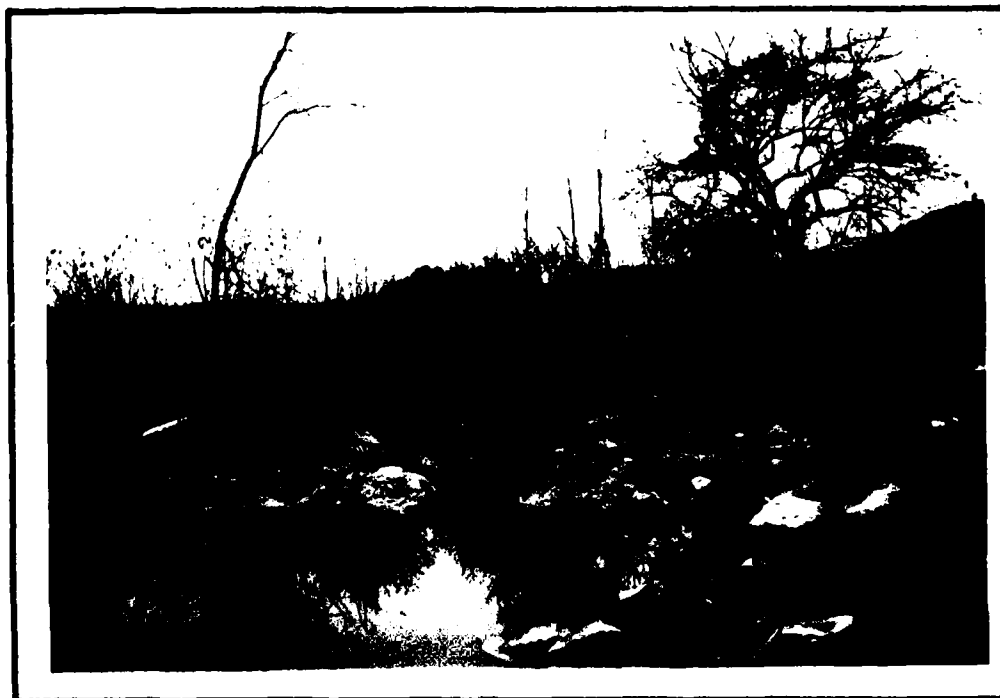
2. LOOKING DOWNSTREAM THROUGH THE SPILLWAY ADJACENT TO THE  
RIGHT ABUTMENT. (12/2/80)

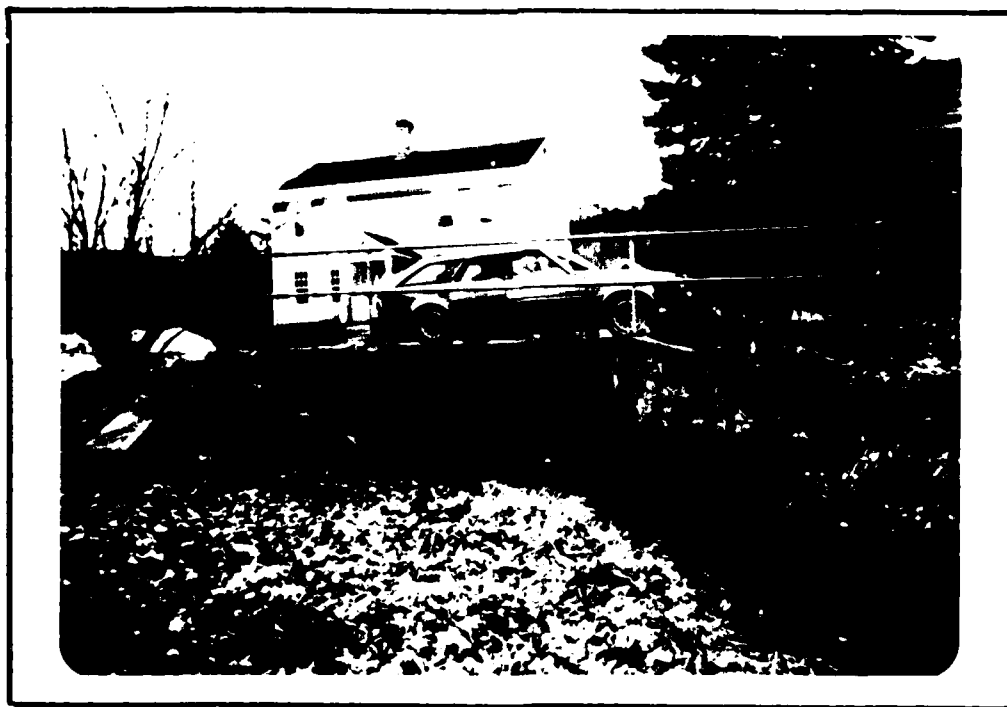
10. INLET TO THE BOX CULVERT APPROXIMATELY 1300 FEET DOWNSTREAM OF THE DAM WHICH CONDUCTS THE STREAM UNDER THE TOWN OF SHELBURNE FALLS. (12/2/80)

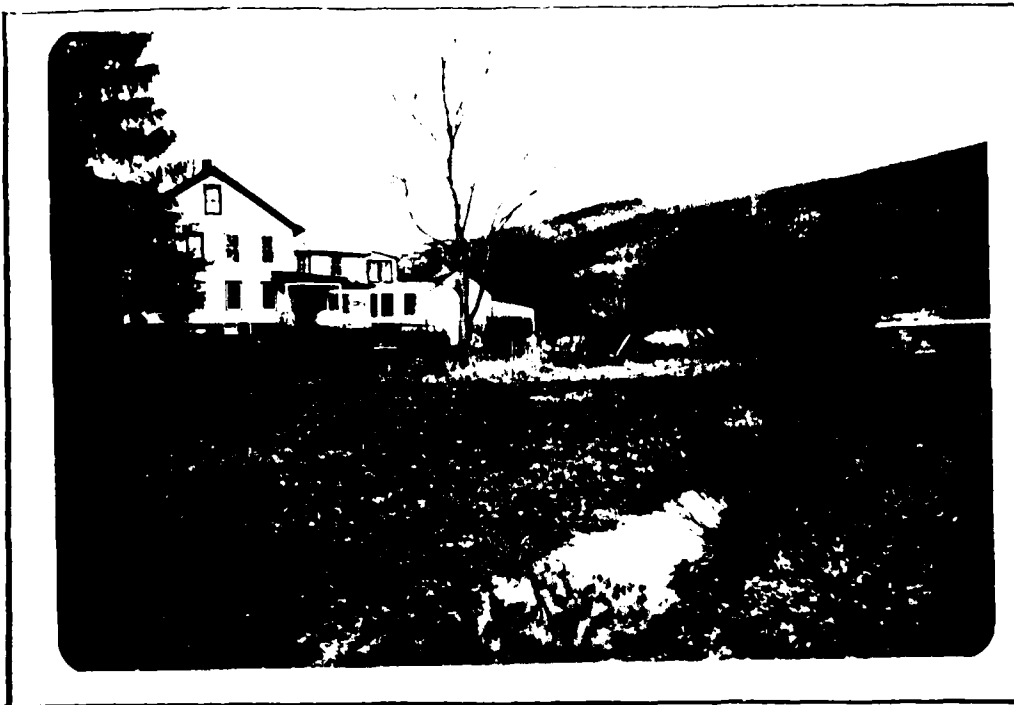
11. POTENTIAL DAMAGE AREA ABOUT 1000 FEET DOWNSTREAM FROM THE DAM. (12/2/80)
